# SNOWDEN OVERLOOK COMMUNITY ASSOCIATION FACILITY MAINTENANCE HANDBOOK

2/1/2019

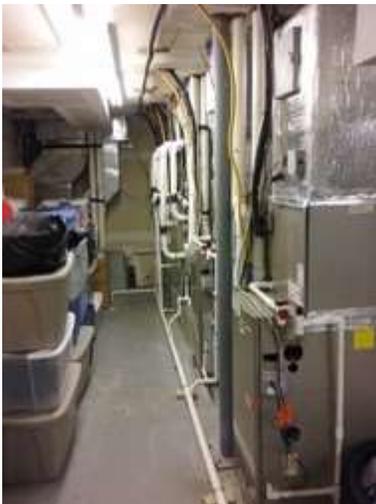
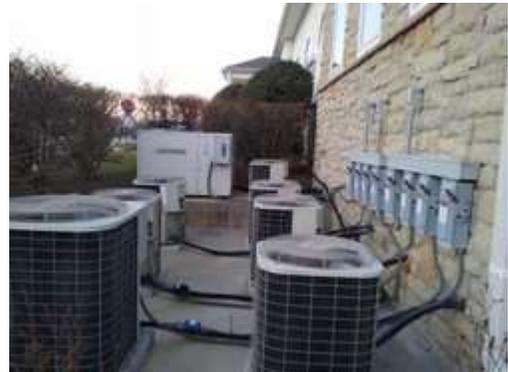
8 HVAC units (serving 6 zones, each with a thermostat) and several electrical heaters serve the clubhouse. All air handlers are in the lower-level furnace room (see below, left), with condenser units outside on a pad by the west wall, next to the driveway (see below, right).

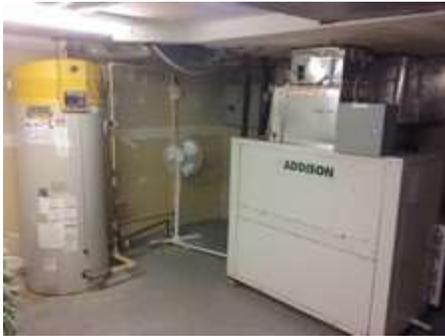
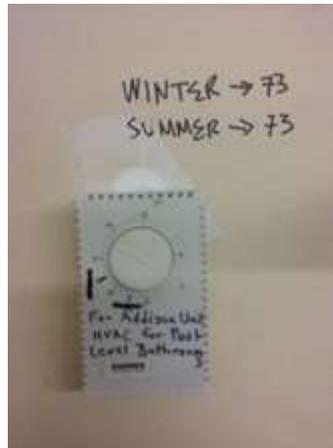
8. Addison "make-up air" unit with 2-stage AC and electric furnace, serving lower level bathrooms. Thermostat measures air temperature in ducts and is located on wall in furnace room between water heater and mop sink. See below.

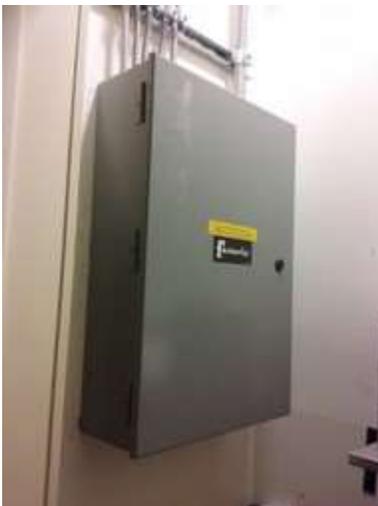
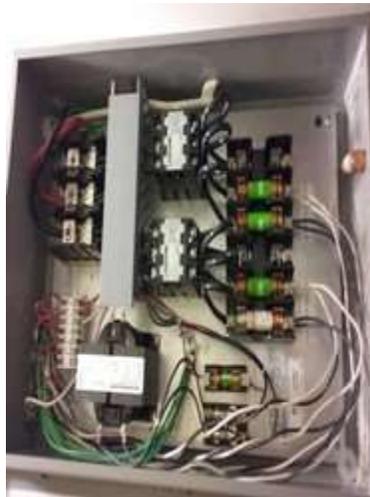
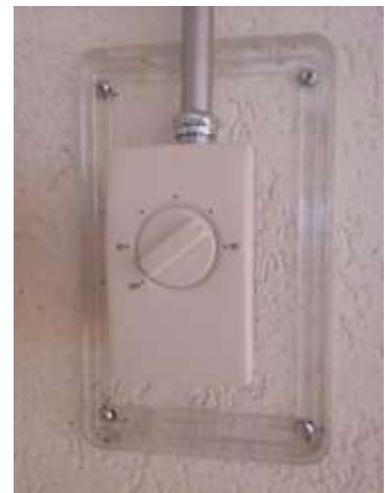
Awning Heaters -- There are 4 overhead electric radiant heaters. The breaker for these units is in one of the panels in the hallway of the main floor. Fuses and contactors (relays) for the units are in the janitor closet off the hallway, see below on left. The heaters are controlled by a thermostat in a locked box in the corner of the awning room, see below on right. Key is in office key box with orange on fob.

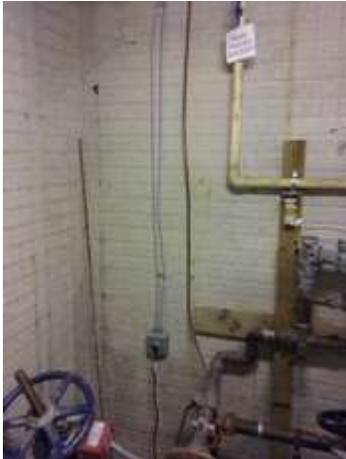
MAIN CUT-OFF VALVE is in NW corner of furnace room; see below. This labeled blue valve on a white pipe cuts off all water to the clubhouse except for that to the fire sprinkler systems. The valve is stiff and may require channel-lock pliers to turn. While there are a few other cut-off valves, including those under each sink, some are not easy to find. This valve is the only sure way to stop the flow of water when in doubt.

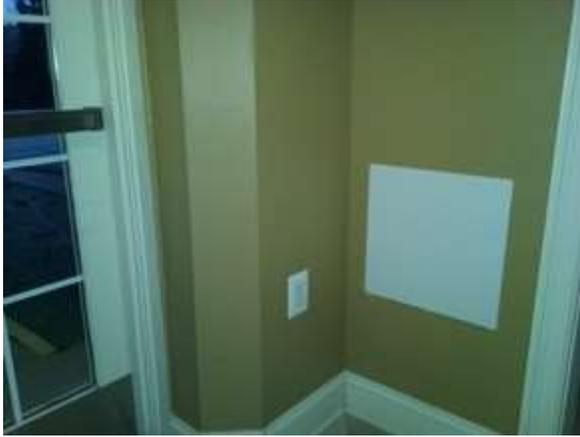
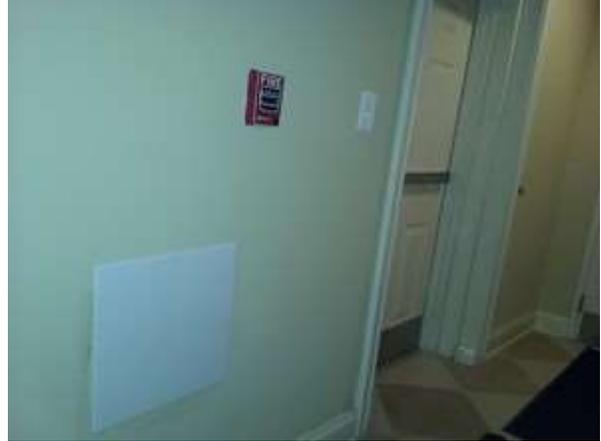
- Hose spigot on main level, through wall at kitchen. Cut-off valve under kitchen sink.
- Hose spigot on lower level, near kitchen wall: Valve is inside near the spigot, behind a white plastic panel low on the wall just inside the door into the "Summer Lounge" room, see below, left. The panel is held in place with spring clips which are released by raising or lowering the panel slightly with your fingers.

Drinking Fountains on lower level: Valve is inside, on the other side of the wall on which the fountains are mounted, behind a white plastic panel low on wall just inside the door toward the bathrooms; see above, right. Panel operates just like the one above.

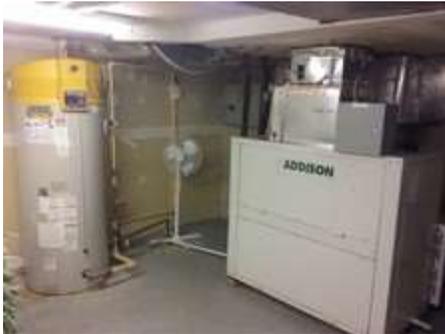
WATER HEATER – High efficiency gas unit is in furnace room against wall to women's room; see below, left side of photo. Small amount of water occasionally appears on floor around heater. Appears to be from exhaust condensation. Exhausts horizontally through north wall of men's room next to driveway. Downward extension pipe added to reduce noise. Temperature can be set from keyboard on unit. On 1/6/2018, it was set at 122 degrees F.

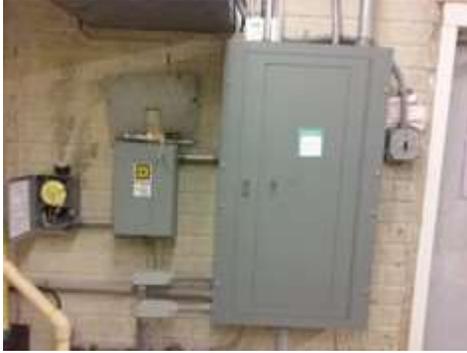
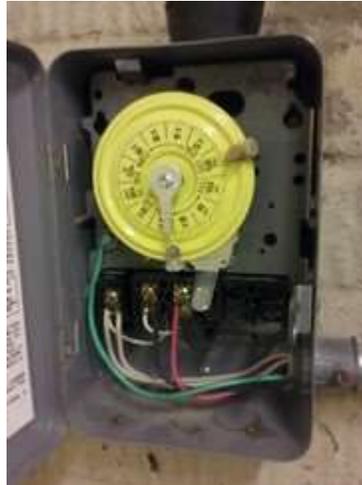
TIMED, CLUBHOUSE EXTERIOR: The timer is in the pool pump room on lower level, in the smallest box to the left of the main panel there, to the left of the door, when viewed from inside; see below. This timer needs to be reset occasionally as the season changes. It has been set to turn the lights on at evening dusk and off around midnight. The timer controls:

- Post lamps on lower level. (Replacement candelabra bulbs in furnace anteroom.)
- Wall fixtures on the main level. (Replacement candelabra bulbs in furnace anteroom.)
- 3 recessed fixtures in front of and over front entrance door on main level. (Same bulbs as interior ceiling lights.)
- Underwater pool lights. These are on a separate breaker in the main panel in the pump room and can

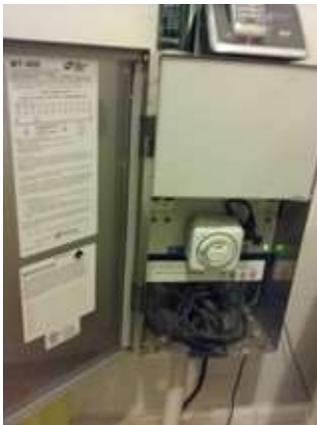
Controller in guard house distributes 12 VAC, see below. All fixtures replaced with LEDs. Power to lights often disturbed by gardening crews in spring and fall. Wiring and wirenut connections then need to be checked. Timer in control box is set to turn lights on at evening dusk and off at midnight.

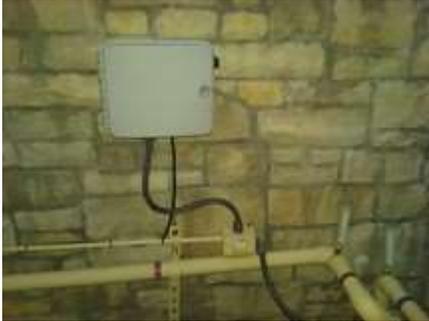
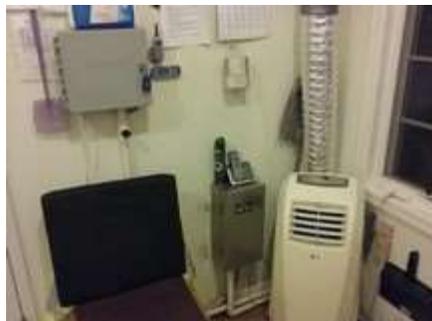
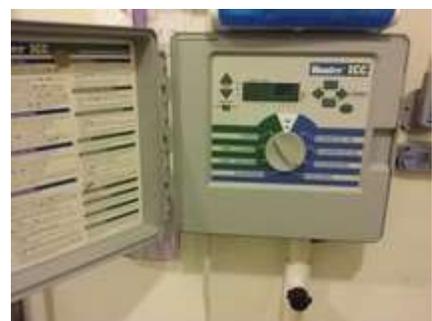
-- Around clubhouse and pool. Hunter controller on wall near pool heater on lower level. Water supply to system is high on right inside wall of pump pool room on lower level; see below, left.

-- Around entrance gate. Hunter controller in guardhouse; see above, center and right. Water supply blow-out port and faucet is behind curved wall on entrance side of gates. Water supply cut-off valve is inside man hole on hill below curved wall. (Access may require a ladder and pump to remove water.)

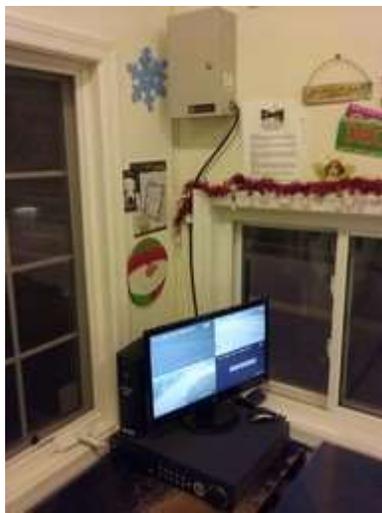
-- Guardhouse – 3- camera system – two on entrance gate with one designed to capture license plates, and one aimed at exit gate. DVR and display in guardhouse; see below. Contractor: Vintange

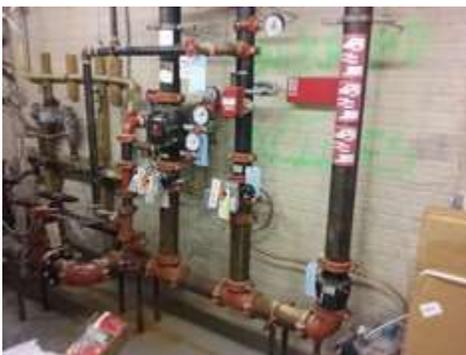
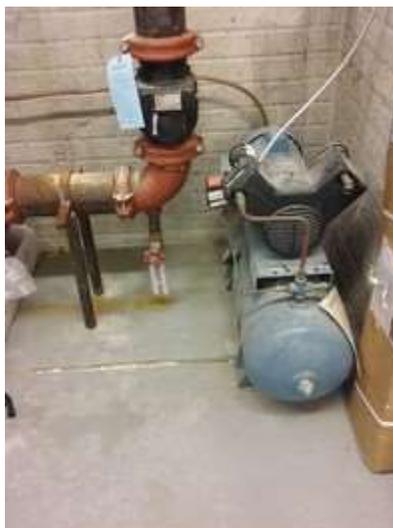
The system on the upper level, including the extension of that system under the awning, is called a dry system. That is, the pipes are not full of water, but of air. An air compressor (below on right) in the furnace room maintains air pressure in the pipes to keep water out, unless there is a fire, and should be checked and serviced regularly by FLSA.

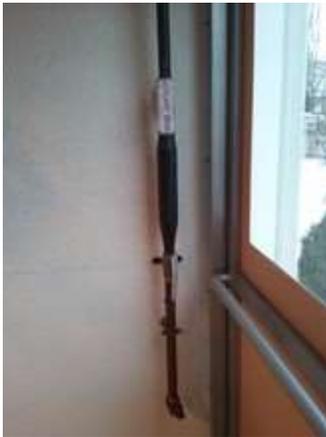
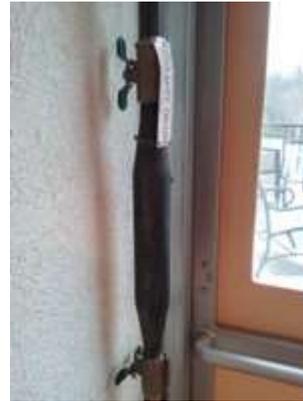
However, the portion of the system under the awning does collect a little condensate water that should be drained occasionally. There are several valves installed for this purpose. The main drain valve is mounted on the wall next to the exit door from the awning (see below, left). The smaller drains are located near the outer (lower) edge of the awning, with valves at the low end of the sprinkler pipes. FLSA should drain all of these at each visit. Some have also been draining the main one by the exit door every month or so, but it has produced very little water -- at most a teaspoon or so. (To drain, remove plug at bottom, close upper valve (see below, right), place container such as watering can over low end of pipe, and open lower valve. Then close lower valve, open upper valve, and replace plug at bottom.)
